Solar PV Systems:

Inspection Techniques, Common Violations, 2014 NEC

March 9, 2017 | John Francis
at Locus Grove
Poughkeepsie NY

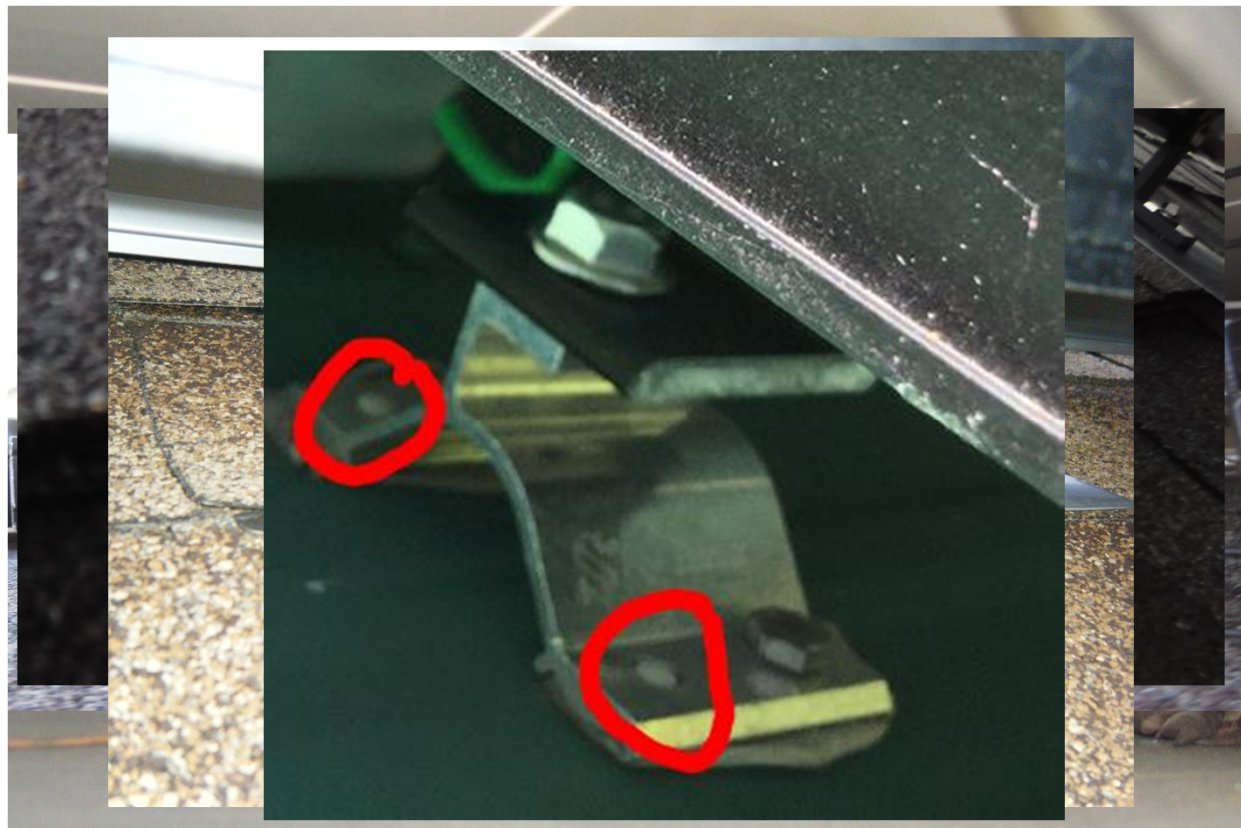
- Postcards from under the modules

Conductors need to be secured and protected from abrasion to prevent potential ground faults. NEC 300.4 & 338.10(B)(4).

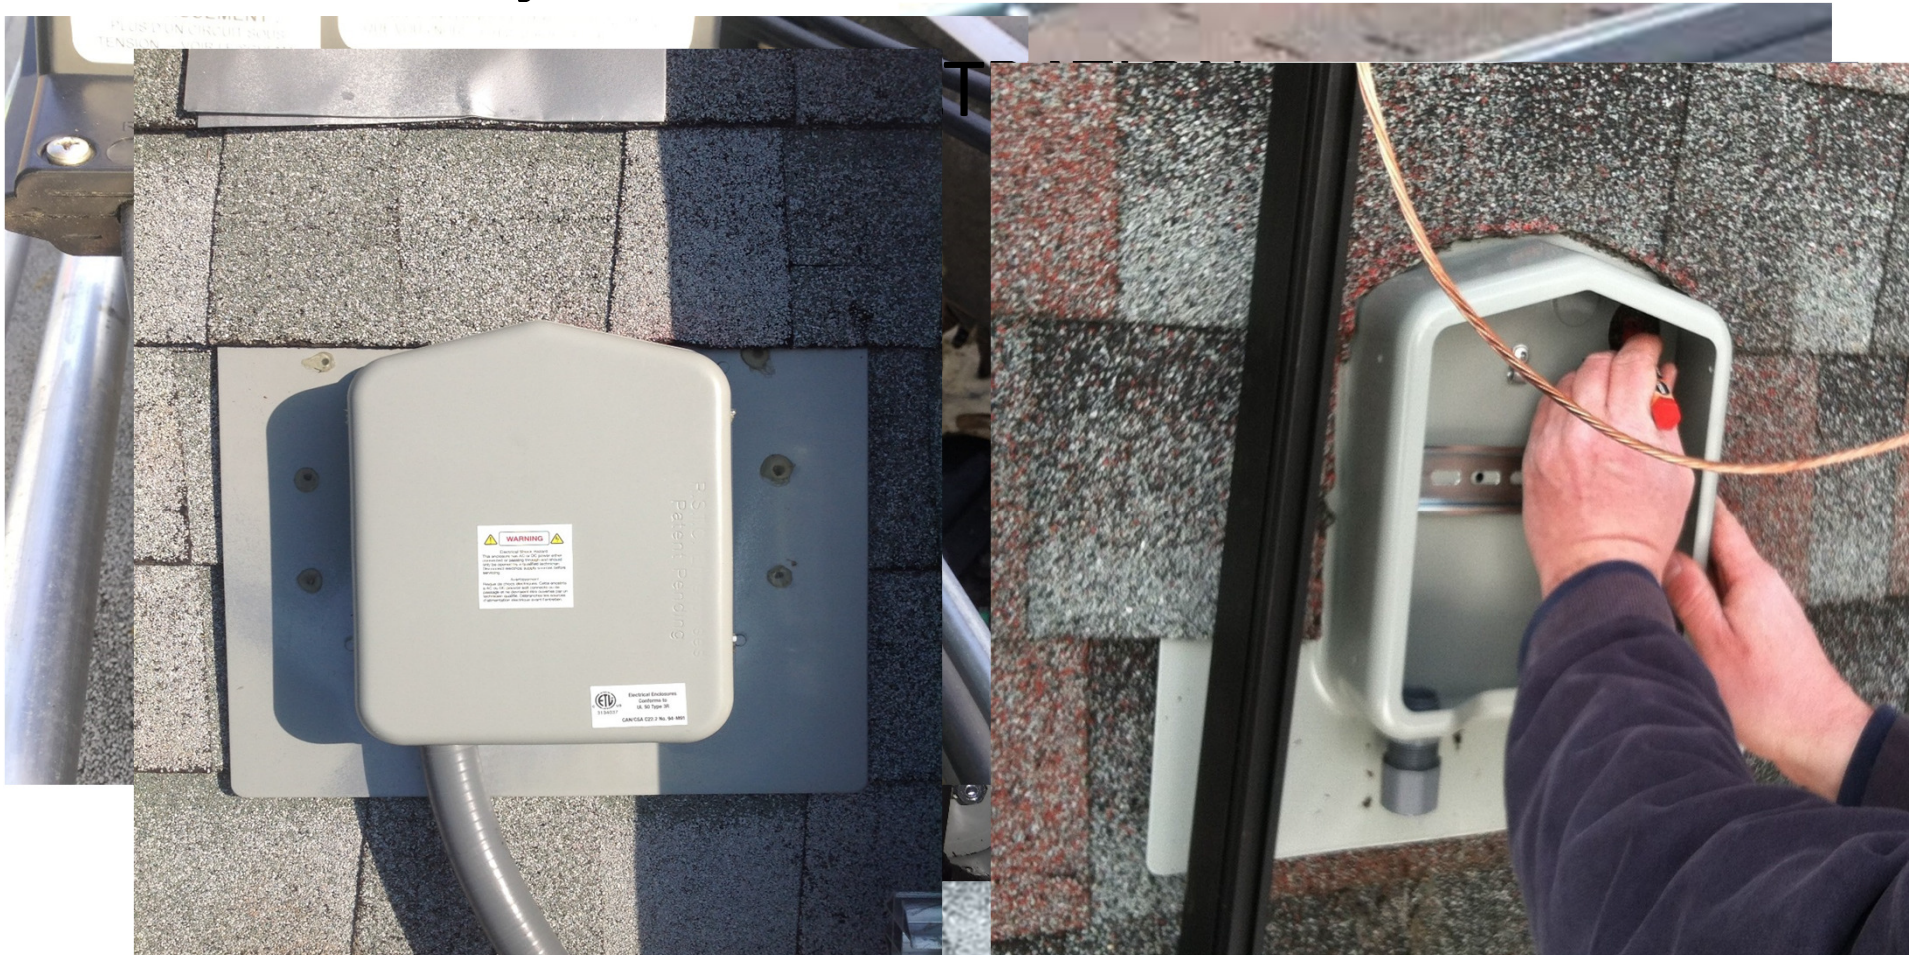
- Conjunction Function: J-boxes

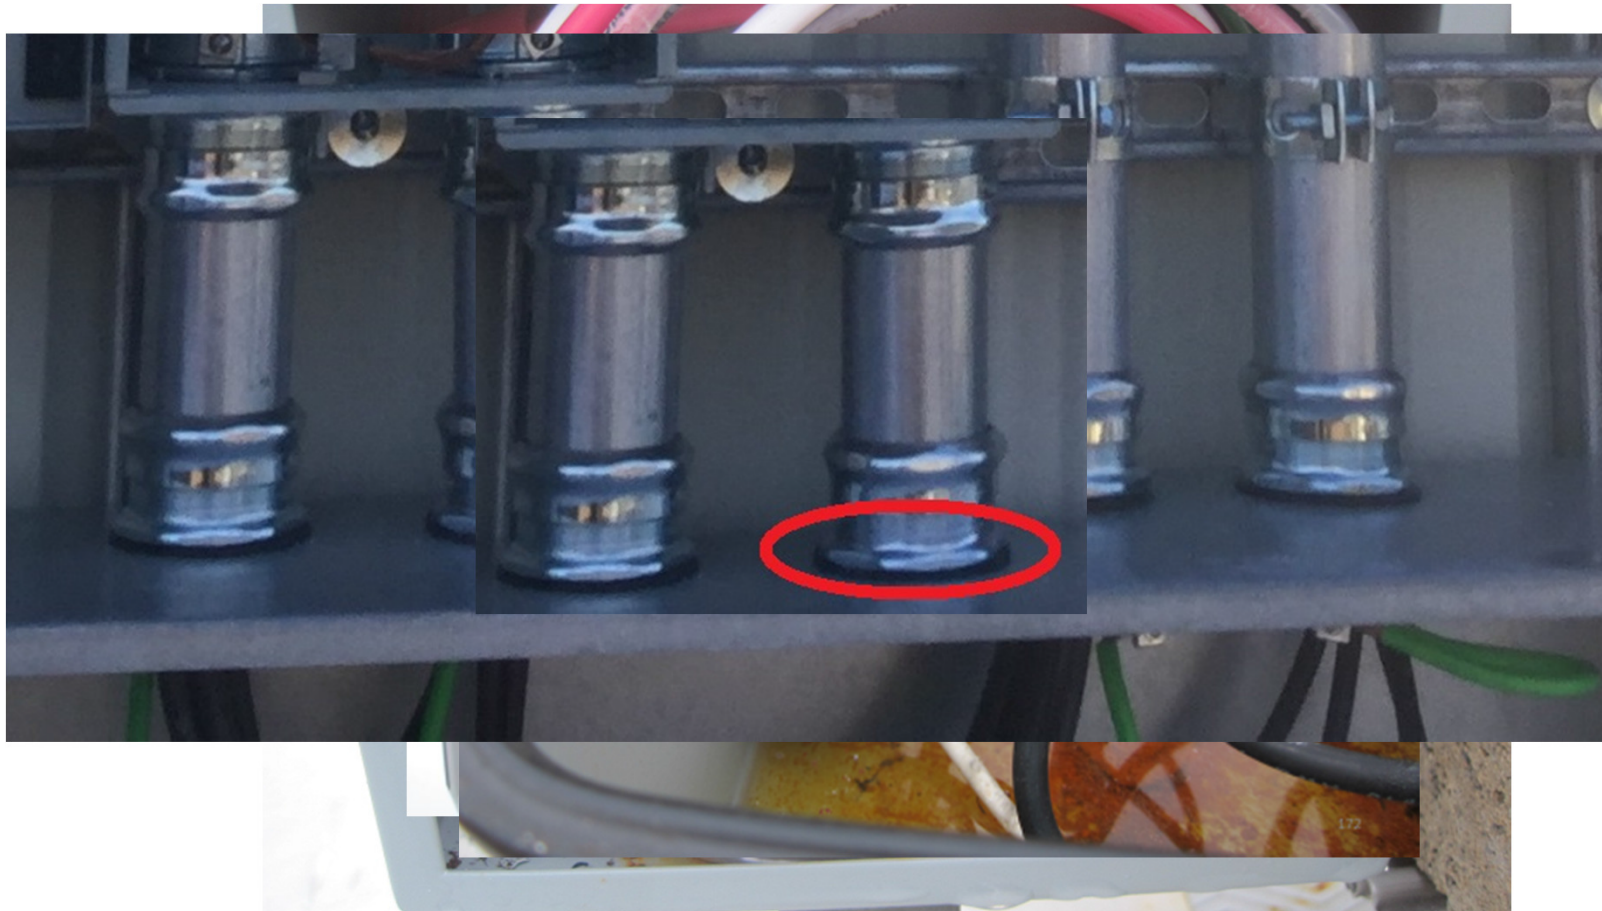
- Conjunction Function: J-boxes

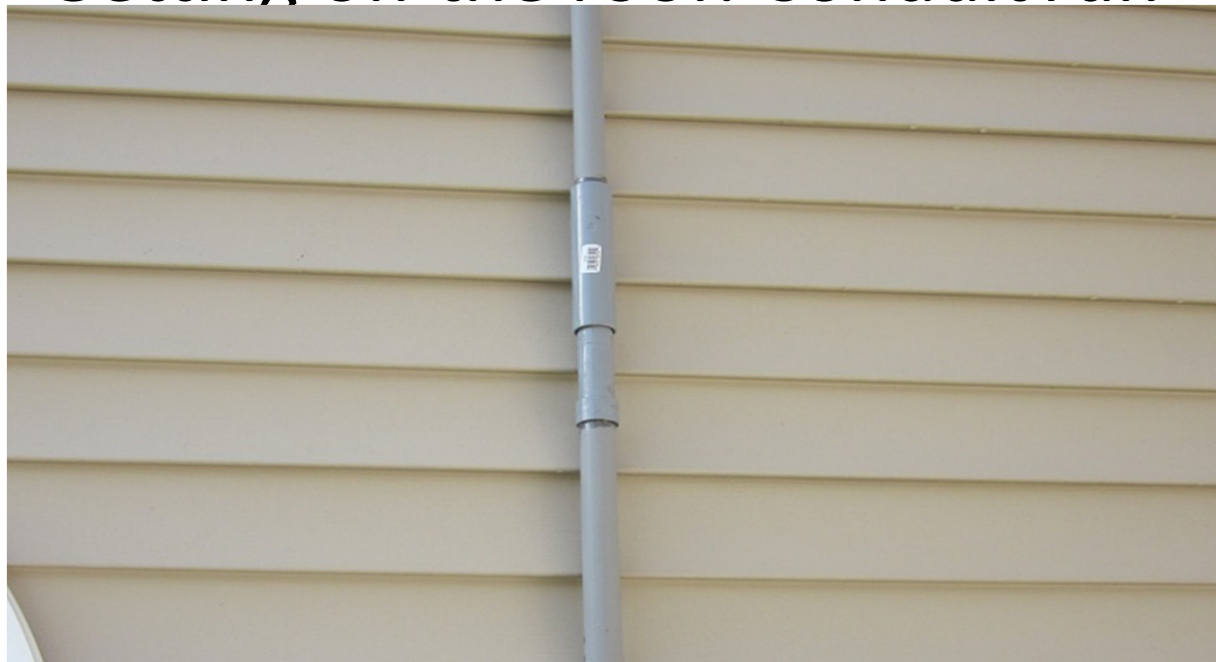
Getting off the roof: Conduit run

**Raceways shall be provided with expansion fittings where necessary to compensate for thermal expansion and contraction. NEC 300.7(B) FPN: Table 352.44
PVC NEC Article 352.44**

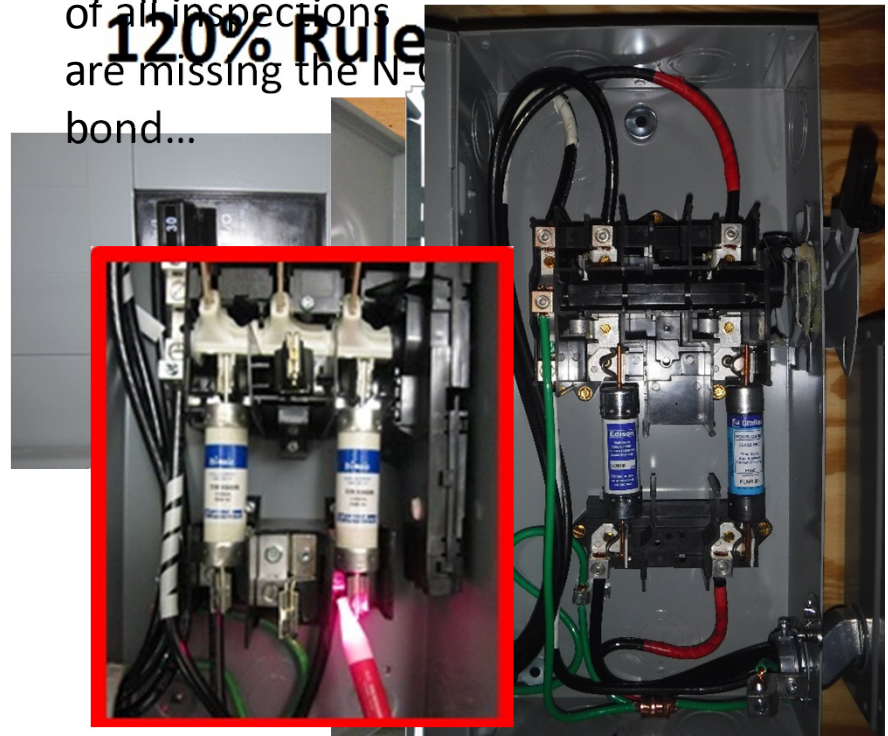
SUPPLY SIDE
 NEC Article 705.12(A)

Approximately **16%**
 of all inspections
 are missing the N-G
 bond...
